Characteristics of Petung Bamboo as the Main Structure of Wide Span Bamboo Hall Building at Gubukklakah, Poncokusumo, Malang

Abstract- *Dendrocalamus asper*, or commonly known as “petung bamboo”, is one of the local bamboo varieties that has a thick and wide stem perimeter. Based on its characteristics, petung bamboo has always been the ultimate choice to be utilized as the primary structure of bamboo buildings from a small span building until a wide span building. Nevertheless, there is limited access to the literature which studies the petung bamboo as the primary structure of wide span buildings. This problem had gained our attention to conduct examination and further study. The examination and analysis of petung bamboo as the primary structure in Gubukklakah Hall building is crucial, due to the structural material recommendation for the architectural design in the future. This study was focusing on the examination of petung bamboo’s characteristics as the primary structure of wide span buildings. There are several methods used in this study such as the qualitative method, literature studies, and case studies. Three important aspects will be discussed in the petung bamboo as th

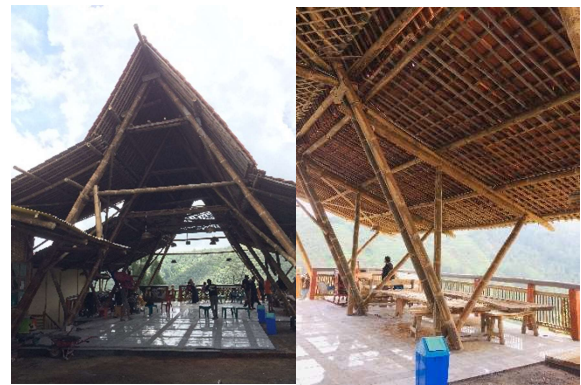
Figure 1. Gubukklakah Bamboo Hall
(Source: Personal Documentation, 2019)

The case study object that will be discussed further is The Bamboo Hall in Gubukklakah, Poncokusumo, Malang Regency. The building is shown in **Figure 1**.

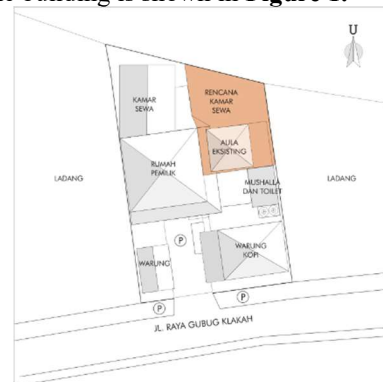
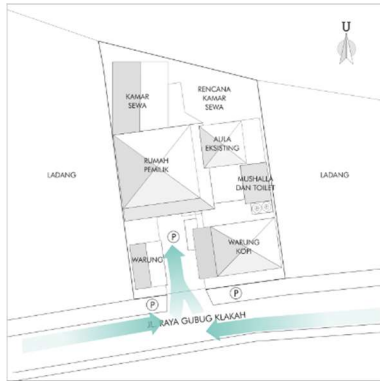
Figure 2. Gubukklakah Bamboo Hall Existing Data
(Source: Personal Documentation, 2019)

It's located at an altitude of 1400 meters above the sea level in the Bromo Tengger Semeru National Park area or commonly known for the BTS National Park area. The existing data are shown in **Figure 2** and **Figure 3**. The hall is designed as an open space that was built using petung bamboo as the material, both for the main structure and supporting parts. Petung bamboo was chosen as the main material of building structures because it's a local commodity in the Gubukklakah region. There are several stages of building a bamboo hall. There are designing, collecting, transporting, and constructing process. The first stage is designing a bamboo hall. The design process has several aspects to be considered such as existing conditions, locality, views, and local human resources. The existing condition of the site is the hall will be constructed above a concrete plate of second-floor building. Then, the building is designed by prioritizing the value of locality. It is using the local material and makes the building form out of the composition and transformation of a traditional house of Dayak Tribe, namely Betang House. After that, the hall is designed to respect nature by capturing the landscape as a main view in the building. To give the excellent view out of the building, the openings face to the north to get a mountain view. The last design aspect is human resources. When designing a good building, the ability of builders needs to be considered too. It becomes important because bamboo has a different construction system than any traditional wood building system. Thus, the building needs to be designed with simple yet strong connections to be easily applied by local craftsmen. The second stage is collecting the materials. In this phase, petung bamboo is harvested directly from the nearest cultivation site. For one segment of petung bamboo, the stem has a length of up to 22 meters. Regarding this situation, transportation can only be done by cutting the bamboo stems per 10 meter long. After the collecting and transporting process, the third stage is the preservation process. Generally, bamboo must go through a drying period, it takes up between six to twelve weeks after being harvested [1]. But in the case study, the drying process only lasts on two to three weeks. It happens because the media is unavailable and the building needs to be functioned

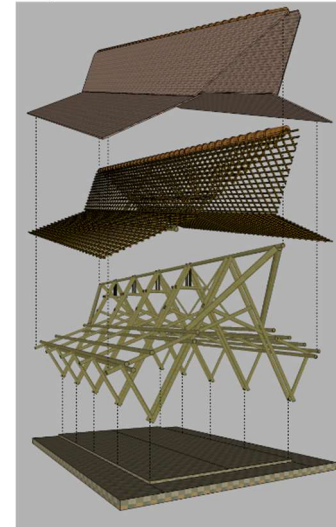
Figure 4. Gubukklakah Bamboo Hall Design
(Source: Personal Documentation, 2019)

At this stage, the bamboo is assembled into 5 modules as shown in **Figure 4**. Next, the modules are joined together. Later, the modules will be strengthened together by adding bamboo bracing at four endpoints. This is intended to strengthen and provide rigidity for the structural system. The next step is installing roof battens and rafters to withstand the roof weight. The last step is installing clay roof-tile to the structure.

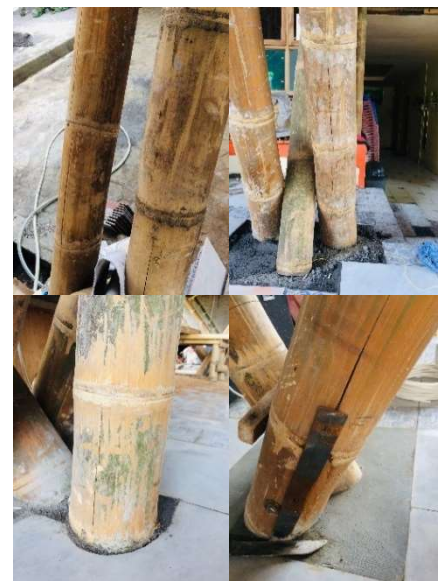
Figure 5. Bamboo Cracks in The Post-Construction
(Source: Personal Documentation, 2019)

There are certain issues that needed to be observed further during the pre and post-construction process of the bamboo hall in Gubuklakah. The first issue is the lack of special treatment for petung bamboo before it is used as the main structural material. The bamboo cracks are shown in **Figure 5**. This issue later will impact on the durability, preservation, and post-caring process of the building. The second issue, regarding the construction process, the structure's strength of both the main structure and detail connections has not been tested. The third issue is the post-construction is known to have several problems, such as bamboo cracks, rusty butts, and bolts, and also the bamboos are unstable due to the shrinking issue because they skipped the drying and preserving process. The fourth issue is the effectiveness of bamboo material used as the main structure needs to be studied further. It's because there are some parts of the structure that are added or subtracted because of the aesthetic and strength of the post-construction process.

Based on the result of studies and building observation, it can be concluded that petung bamboo needs through a drying and preservation process before it can be used as a building structure material; the environmental condition can affect the age of the building because it affects the resistance of petung bamboo; utilization of petung bamboo in Gubuklakah hall

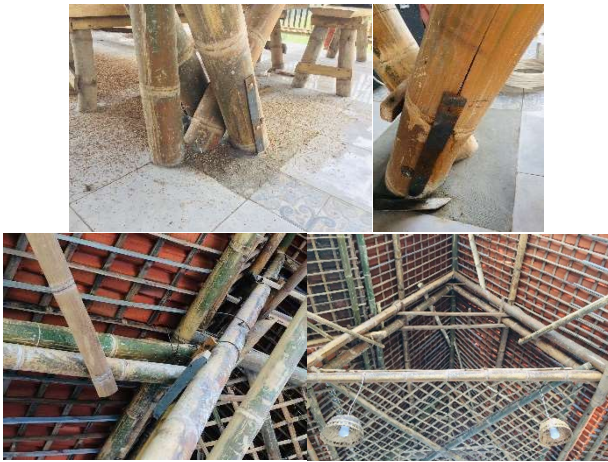
Figure 6. The rust on Nuts and Bolts
(Source: Personal Documentation, 2019)

The importance of study the bamboo hall building in Gubuklakah is to know the quality, advantages, and weakness of the bamboo petung as the main structure on the object. The several aspects that need to be studied further are the special treatment that should be done for petung bamboo; the simple structure strength test analysis with SAP 200 program; the reason that causing cracks on bamboo stem, the nuts and bolts rust, and expand-shrink character; also to the effectiveness of using bamboo petung as the main material. The nuts and bolts ruts are shown in **Figure 6**.

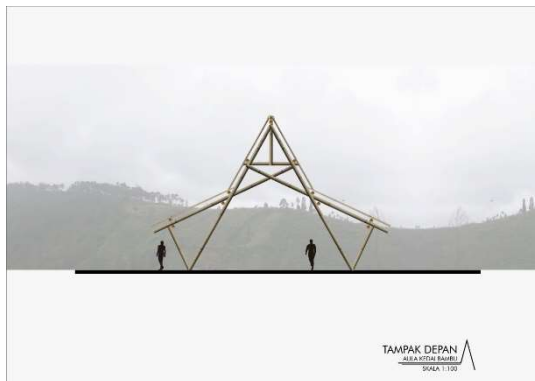
Figure 7. The Triangular-Shaped Module for Gubuklakah Hall
(Source: Personal Documentation, 2019)

The bamboo structure on the Gubuklakah hall is done without going through any preservation process. This case, makes the strength of the bamboo structure questioned whether the structure can withstand heavy loads. The hall building is

constructed by combining triangular-shaped modules as the basic shape. The structure appears as in **Figure 7**.

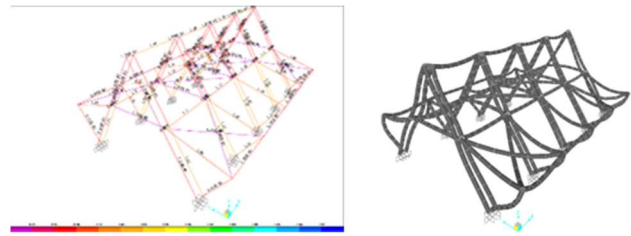
Figure 8. SAP 2000 Program for Gubuklakah Hall Structure Analysis
(Source: Personal Documentation, 2019)

The analysis is processed by the SAP 200 program which tests the load of the bamboo structure. The analysis process appears as in **Figure 8**. The load that comes from the roof will be simply analyzed the condition of the bamboo structure after bearing the load. It is shown that the horizontal structure received a heavy load. It has an impact of deflection on the vertical structure. The problem due to the lack of structure from a smaller surface that holding the roof loads.

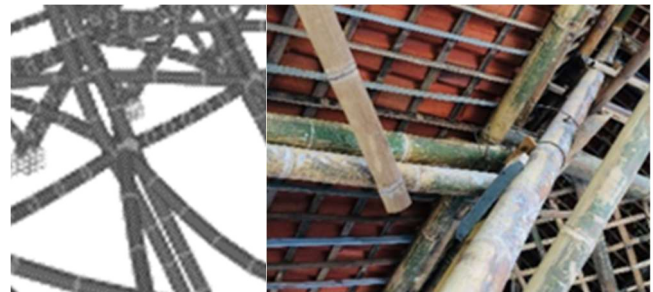
Figure 9. The Retaining Beams on Bamboo Structure
(Source: Personal Documentation, 2019)

In the study case, there were only two retaining beams which received heavy loads from the roof. The retaining beams are shown in **Figure 9**. It happens differently on the main structure conditions, the structure can hold the load from the roof. It can suffer from the structure deflection because the roof load can be distributed directly to the ground.

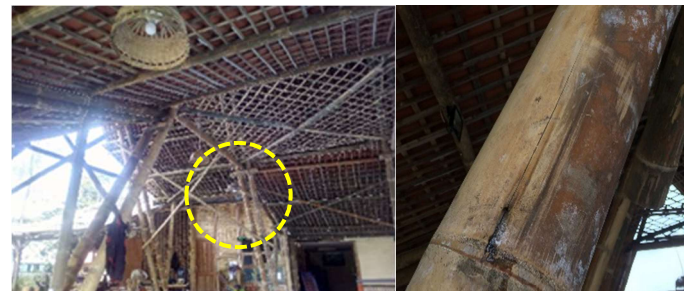
Figure 10. The Bamboo Crack on Retaining Beams
(Source: Personal Documentation, 2019)

The other damage that found is the bamboo cracks. It found majorly on the connection between the main structure and the retaining structure of the side roof. In this area, the bamboo cannot be able to withstand the load from the roof and it caused an enormous pressure that makes the bamboo is broken. The crack on the retaining beams is shown in **Figure 10**.

According to Professor Andrew W, Chalerson (2019), the author of Structure as Architecture book, the structure of Gubuklakah Bamboo Hall has a less secure where the positioning of the bracing is less precise which the placement is right on the top area of the roof system. The bracing is not directly related to the main structure, so it is still prone to shock or excessive loads that affect the building. The cracks of petung bamboos which used as a structure are a form of bamboo that tries to distribute the load evenly. On the ground, the bamboo that is used is not really straight but has a slightly curved shape. So, that the loads received by bamboo must be equal. The equality of load causes cracks on the bamboo which makes the load evenly distributed on the whole structure.

Several solutions for structure addition which can be done are bracing addition in the main structure and beams and columns addition on the retaining area of the roof system.
